Anti-icing Teflon Cover

Evaluation report

Alcatel-Lucent Schweiz AG

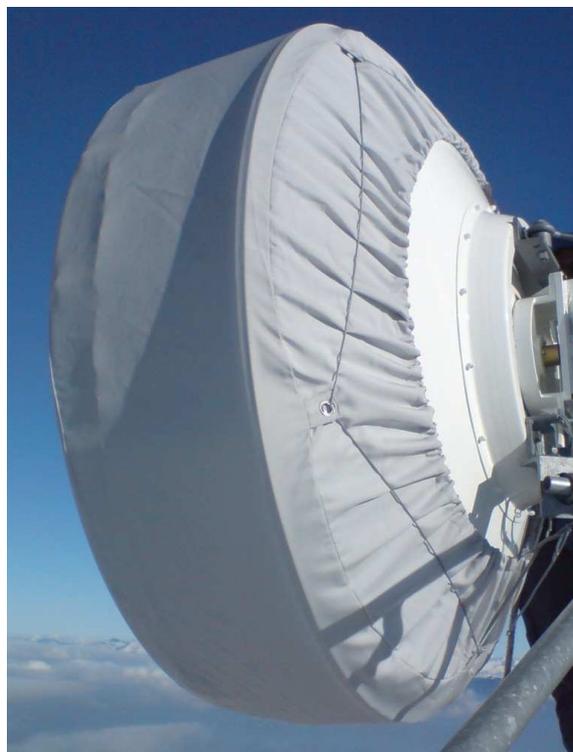
Figure 1 - Anti-icing Teflon cover

Teflon cover is an alternative anti-icing system destined to replace the heating system to present in use on OCH network. This system is made with a cover enveloping the Microwave antenna and maintained by rope. The cover is made from Teflon material and his design is adapted to the shape of the Antenna.

The rope used to maintain the Teflon cover is UV resistant as well as the thread used to assembly the pieces of the envelope.

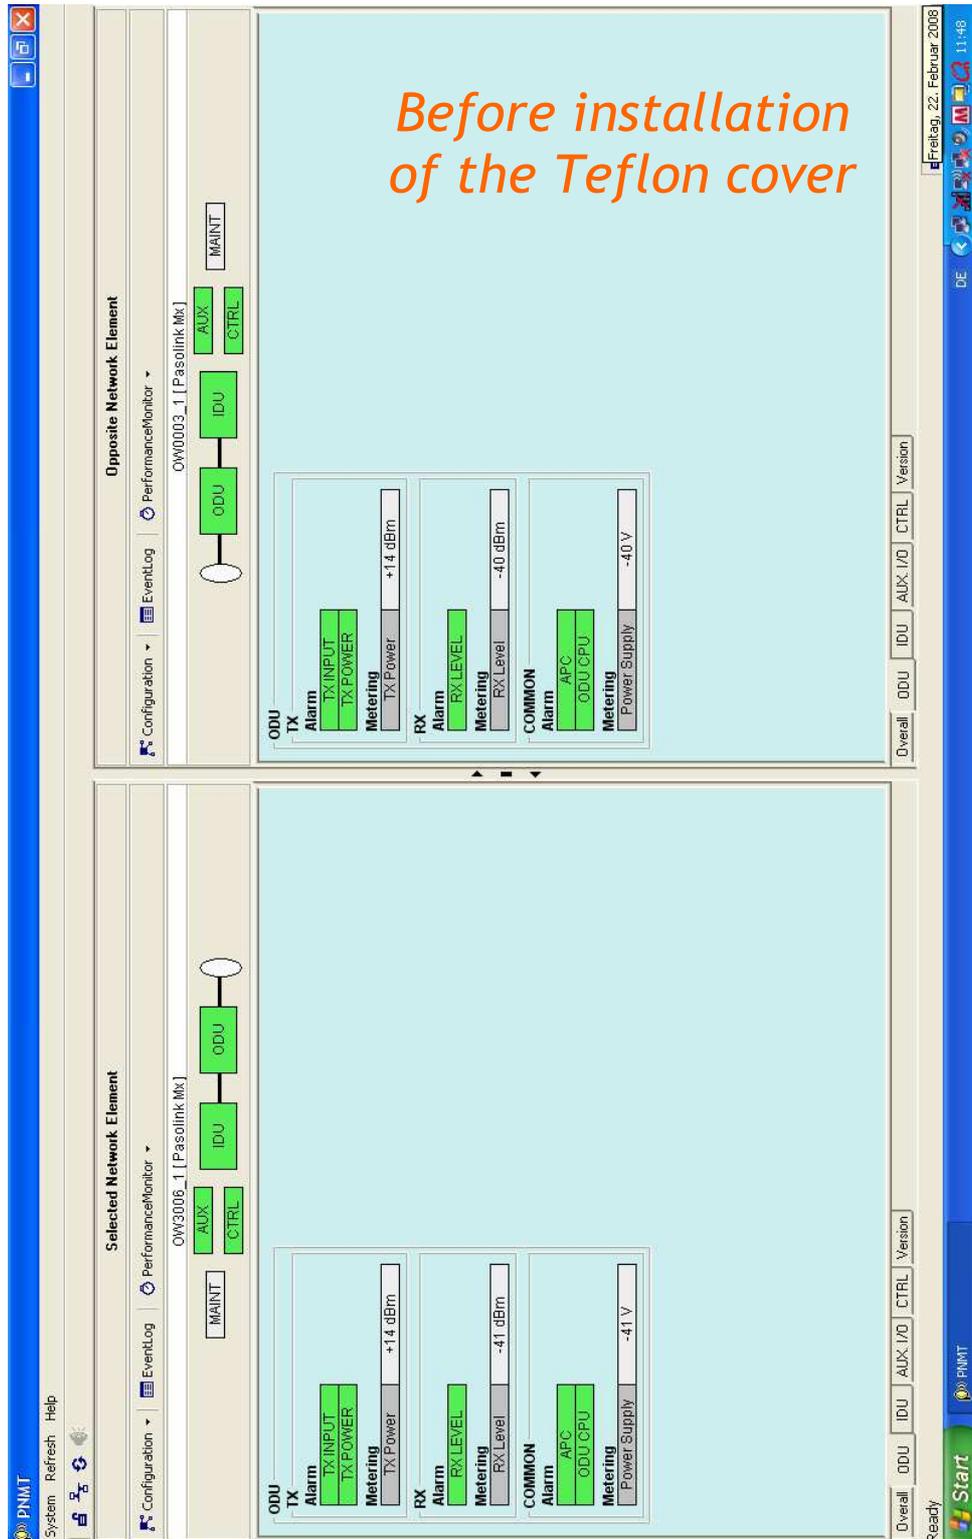
Figure 2 - Levels before installing Teflon cover

The level of signal receive on both extremity has been controlled before and after the installation of the Teflon cover in order to verify that no perturbations are related to the installation. The idea was also to verify that the Teflon cover doesn't have any effect on Microwave signal propagation.

Example on link 25476 OW3006-OW0003 NEC below:

No degradation of the signal level were found, which confirm that the Teflon cover have no significant negative impact on the Microwave link quality of service.

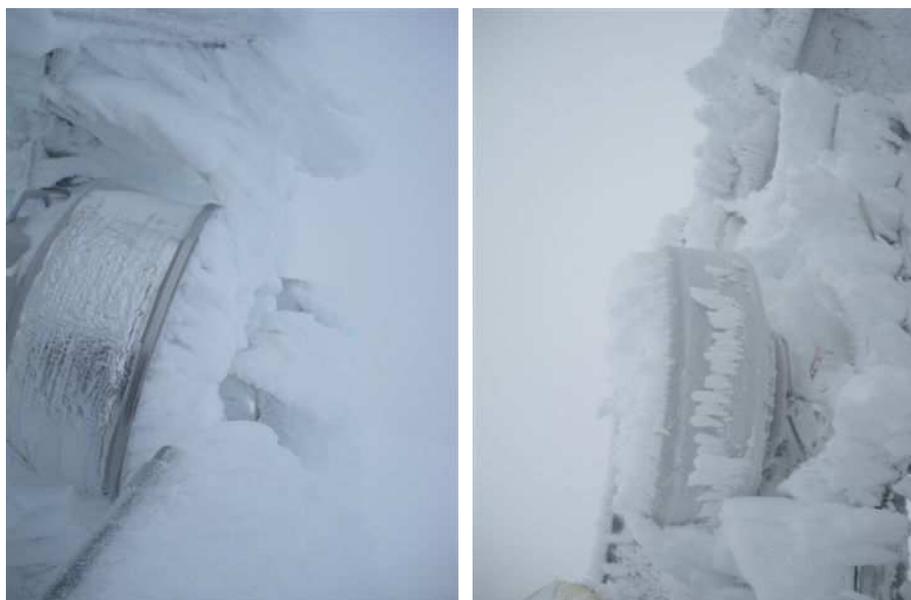
Figure 4 - Titlis dishes on 25/12/2008

The pictures below were taken on 25/12/2008 after a snow storm. They show an accumulation of blowing snow on the front of both dishes fitted with heating system or Teflon cover. Then we can conclude to a draw, but we learn that in harsh conditions (low temperature, high wind) the snow can stick on Teflon.

Heating system

Teflon cover

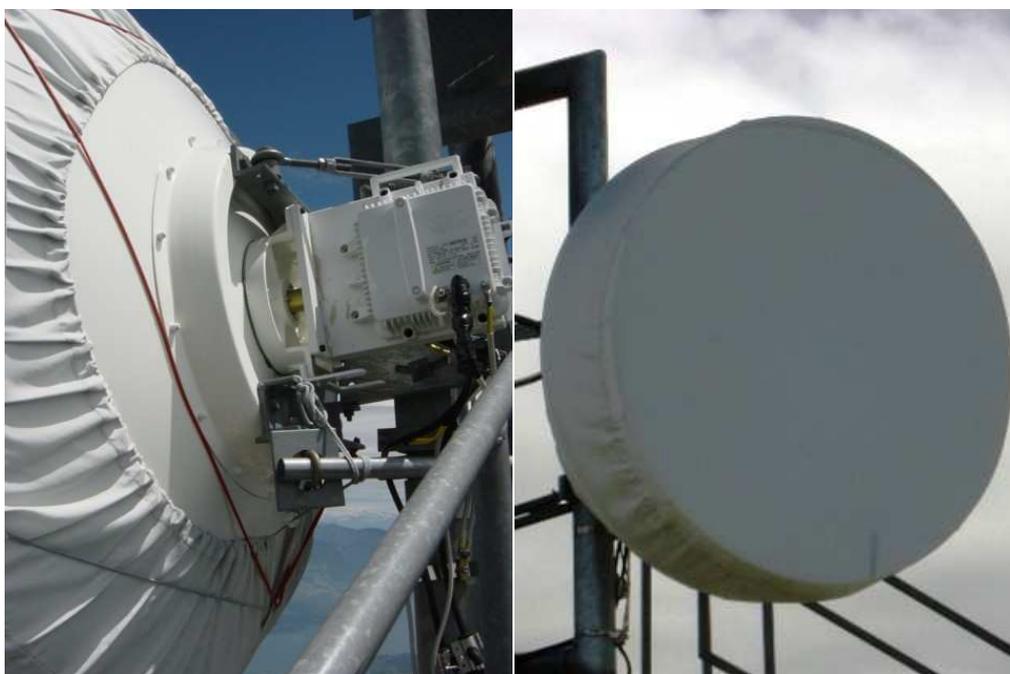
Figure 5 - Teflon cover from Stockhorn 16 months after installation

After 16 months being installed on Stockton a recent visit on 16 June 2009 hasn't shown any damages on the Teflon cover.

Teflon cover is made from a simple Teflon envelope. The simplicity of the concept and the resistance of the Teflon material guaranty an excellent longevity and limited maintenance.

However the longevity of the Teflon cover has to be demonstrated in the next coming years. Seam and ropes could represent a weakness of the Teflon cover. Thread and rope are reputed UV resistant.

Maintenance: Teflon cover is made from a simple Teflon envelope. The simplicity of the concept and the resistance of the Teflon material guaranty an excellent longevity and limited maintenance. However this have to be confirmed in the coming next years, but a recent visit on Stockhorn shows that the Teflon cover doesn't present any damages or alterations after 16 months passed on site.
